**STRUCTURAL PERFORMANCE DUE TO ENGINE VIBRATION USING  
THE LEVELLING TIME HISTORY METHOD**

**<sup>1,2,3,4,5,6,7</sup> Sumatra Institute of Technology**

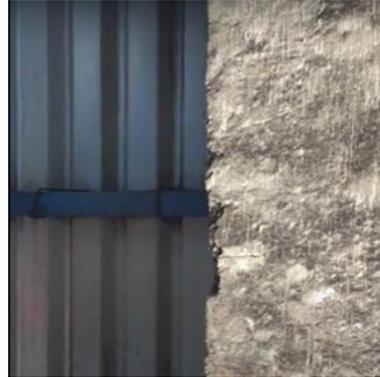
Observations were carried out to find out and identify problems that occurred in the Coal Crusher Building. One of the images shows the cracks that occur and the vibrations that can be felt while in the building.

**Figure 3. Cracks occur in the columns and vibrations in the walls can be felt. Data Deflection Check**
