**STRUCTURAL PERFORMANCE DUE TO ENGINE VIBRATION USING  
THE LEVELLING TIME HISTORY METHOD**

**<sup>1,2,3,4,5,6,7</sup> Sumatra Institute of Technology**

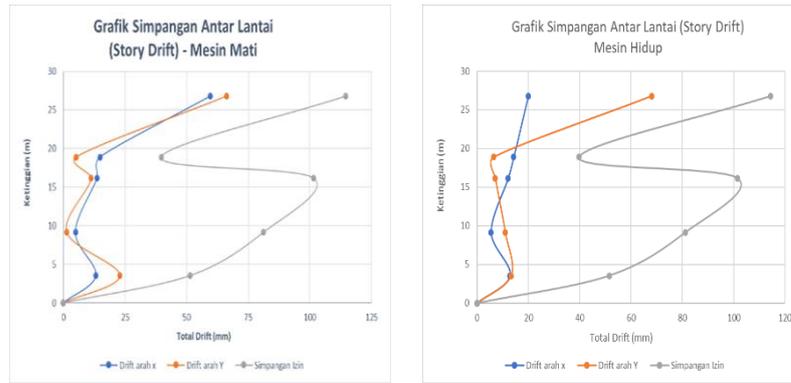
**Figure 5. Curve of Deviation Between Floors (a) Engine Shutdown Condition, (b) Engine Condition. From the review and data obtained, the change in joint displacement when the engine is turned on in the x direction is smaller, which is 11,704 mm compared to when the engine is off in the x direction, which is 19,318 mm. Engine vibrations that occur at the highest point dampen the displacement that occurs.**

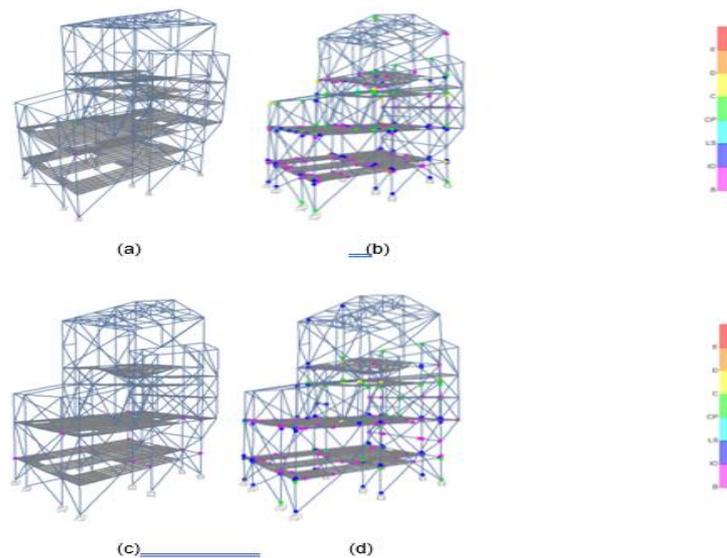
Checking plastic joints is carried out by increasing the value of Aog (initial acceleration of the earthquake) until it reaches conditions above the CP (Collapse Prevention) that occurs in the 3D model of the building.

**Figure 6. (a) 1xAog Indicator Direction X, (b) 10xAog Indicator Direction X, (c) 1xAog Indicator Direction Y, (d) 10xAog Indicator Direction Y Maximum Deviation**

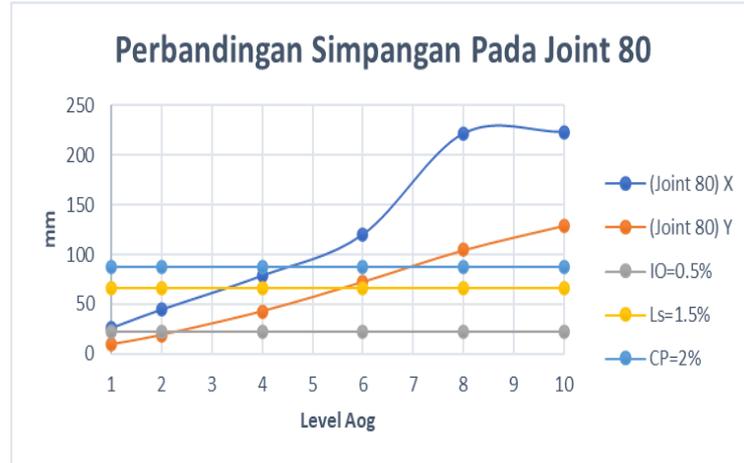
From the deviation table, joints 80 and 100 during the El Centro earthquake in the direction of X and Y. Joint 80 is the joint that first experienced a plastic joint and was above the CP when the indicator reached 6x Aog for the El Centro X Earthquake and 8x Aog for the El Centro Y Earthquake. Chart of divergences that occur at joints 80 and 100.

Figure 7. Joint 80 Maximum Deviation Chart with FEMA (level of damage) limits.

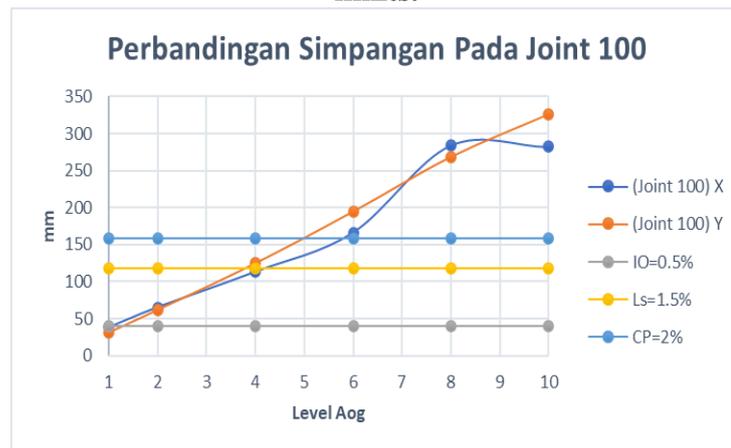
Figure 8. Joint 100 Maximum Deviation Chart with FEMA (level of damage) limits.

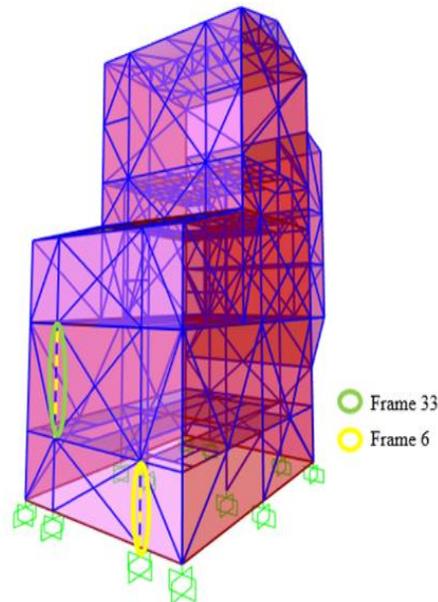
**Figure 9.** Review of rotation during the El Centro earthquake.

From the table above, it can be seen that the overall condition of the building during the initial acceleration of the El Centro Y earthquake was still in IO condition. However, to see to what extent the building or structural element under review has been above the CP. The CP condition was obtained during the initial acceleration of the earthquake at 8 times and was above the CP when the value of Aog El Centro Y increased at 10 times the increase in Aog. There is a difference in the behavior of the structure in the displacement and rotation checks, which means that the structure will reach the maximum plastic joint indicator if one of the structural behavior

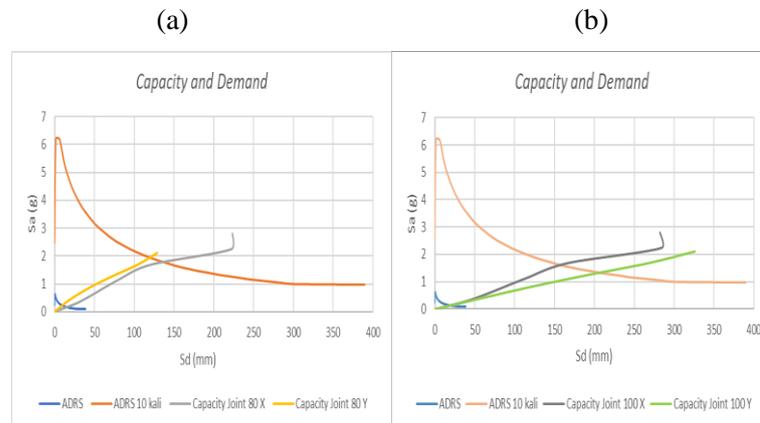
Figure 10. (a) El Centro X Capacity/Demand Curve and (b) El Centro Y Capacity/Demand Curve

The relationship curve that occurs in joints 80 and 100 shows the structural performance that occurs in the building. This is also to ensure that the performance conditions that occur (capacity) have intersected with the ADRS (Demand) line. Previously, the review and analysis carried out on the structural performance at the intersection had been above the CP (Collapse Prevention). Therefore, based on the Capacity and Demand relationship curve, the analysis of the deviation shows that there is a point of performance and the load received by the building has exceeded the strength limit of the planned structure, such as the analysis of structural performance at the deviation carried out at joints 80 and 100 during the El Centro X and Y earthquakes.
